INDOOR AIR QUALITY ASSESSMENT

**Pepperell Town Hall
1 Main Street
Pepperell, MA**

Prepared by:
Massachusetts Department of Public Health
Bureau of Environmental Health
Indoor Air Quality Program
January 2020

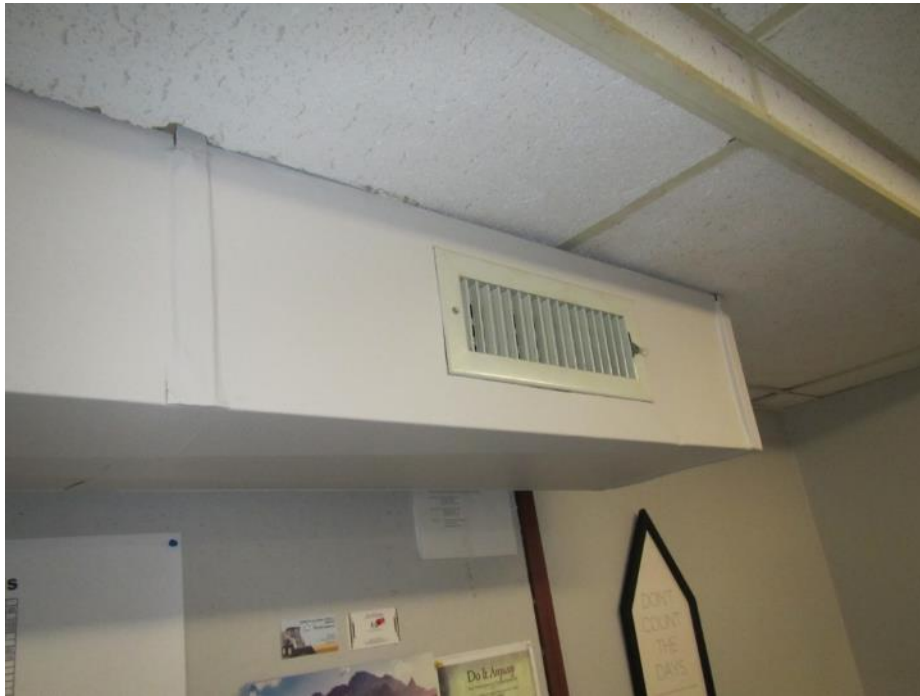
Picture 1

The building is supplied with fresh air from an air handling unit (AHU) located on the lower level. Air is supplied to occupied areas through vents from exposed ductwork (Picture 1) or the ceiling (Picture 2). Return vents return air to the AHU. There are radiators for supplemental heating and, in some areas, window/wall-mounted air conditioners for additional cooling (Picture 3). There are also vents in the attic level room (Picture 4). It is unclear whether these are attached to an existing mechanical system. They are mostly blocked with plastic.

Ductwork with supply vent

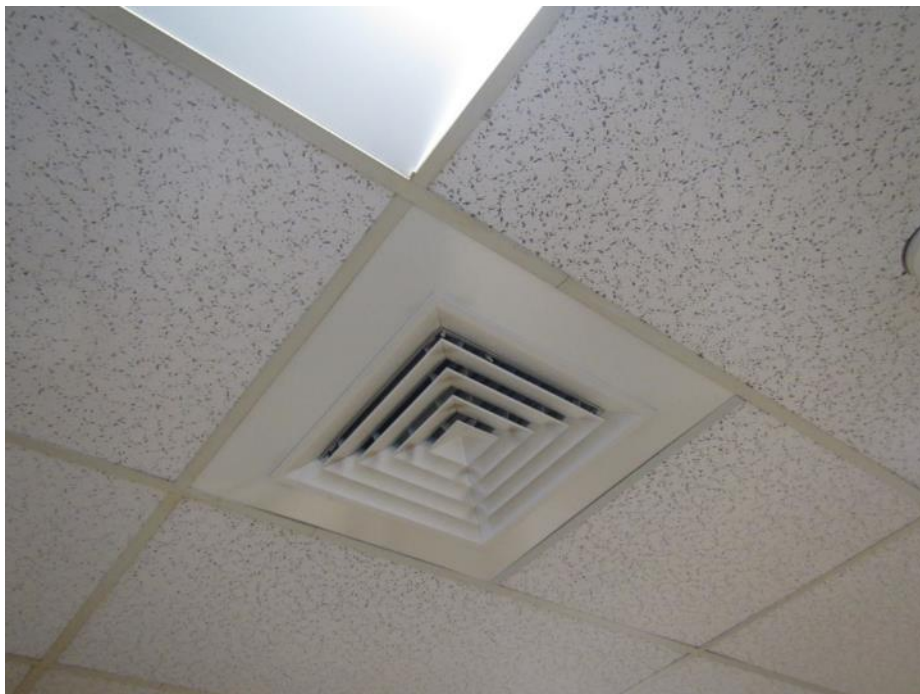
Picture 2

Supply vent in ceiling tile system

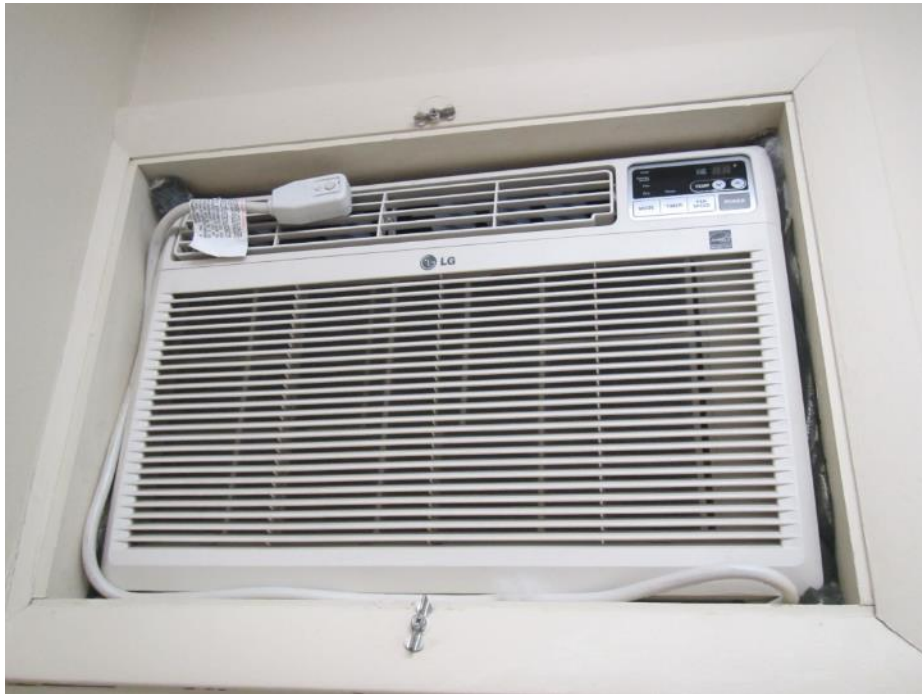
Picture 3

Odors were reported in several areas of the building, including the Selectmen's office area. Occupants of this area reported that in the past a strong musty odor had been present and a source not identified. A slight odor of hand sanitizer was noted in the outer office during the assessment, but the musty odor described was not present at the time of the assessment. Reportedly, the odors are strongest during wet weather. There is material around the wall-mounted air conditioner in this office that may be porous (Picture 3). This should be checked and replaced if necessary with a non-porous material that forms a tight seal.

Wall-mounted air conditioner

6. Maintain plumbing to prevent leaks.
7. Seal around window ACs using non-porous materials.
8. Ensure that air conditioning systems are cleaned prior to the beginning of the cooling season to reduce odors.

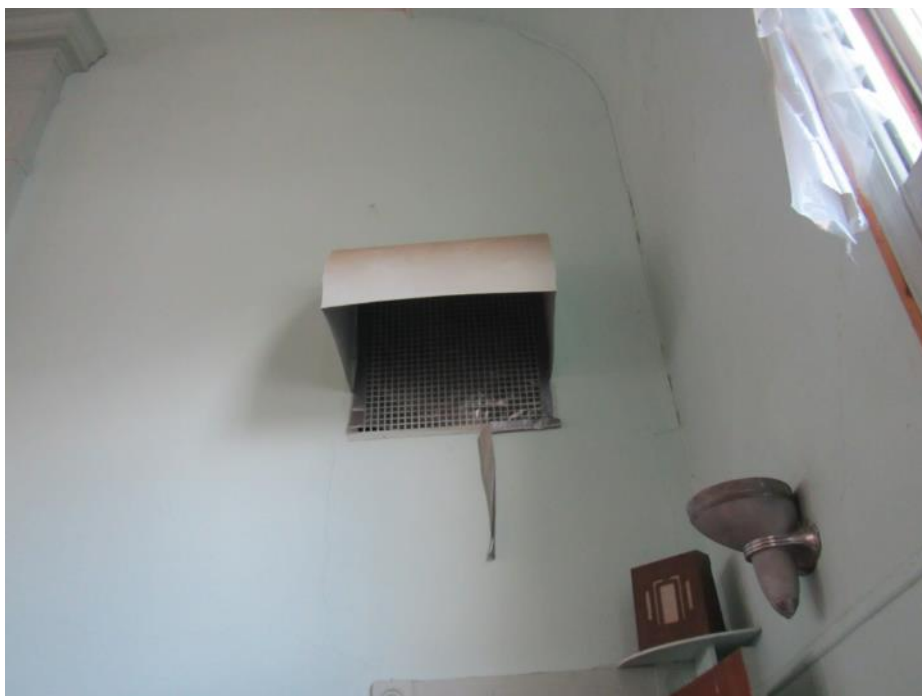
Picture 4

Vent in attic level room with plastic over it, note tape peeling off

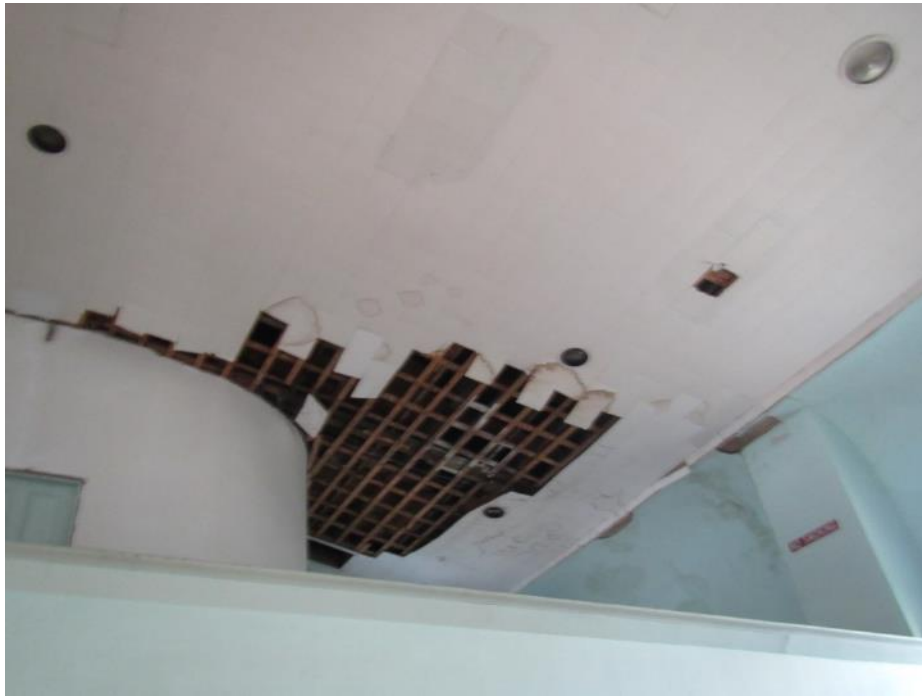
Picture 5

The upper level was formerly a large meeting room/stage and is currently used for storage. The ceiling between this room and the roof is in very poor condition (Pictures 5 and 6). Windows are also in poor condition in this area and do not close completely (Picture 7). Water damage and pest infiltration (squirrels) have been reported.

Damaged ceiling in the upper level

4. Until the roof can be repaired, periodically inspect areas of known leaks.
5. Seal windows and other gaps in the building envelope to exclude moisture and pests.

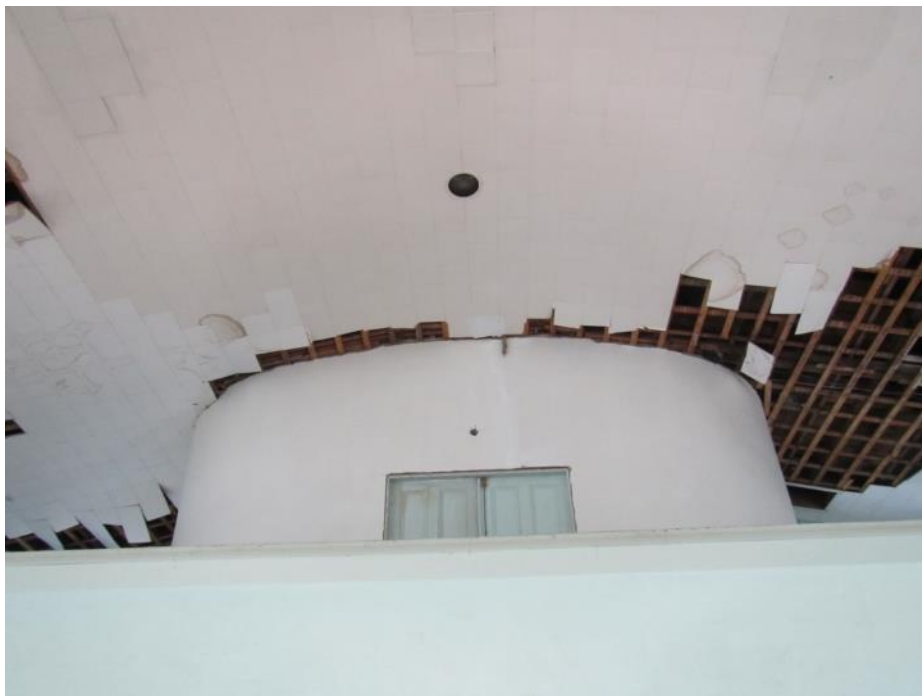
Picture 6

Damaged ceiling next to the cupola on the upper level of the building

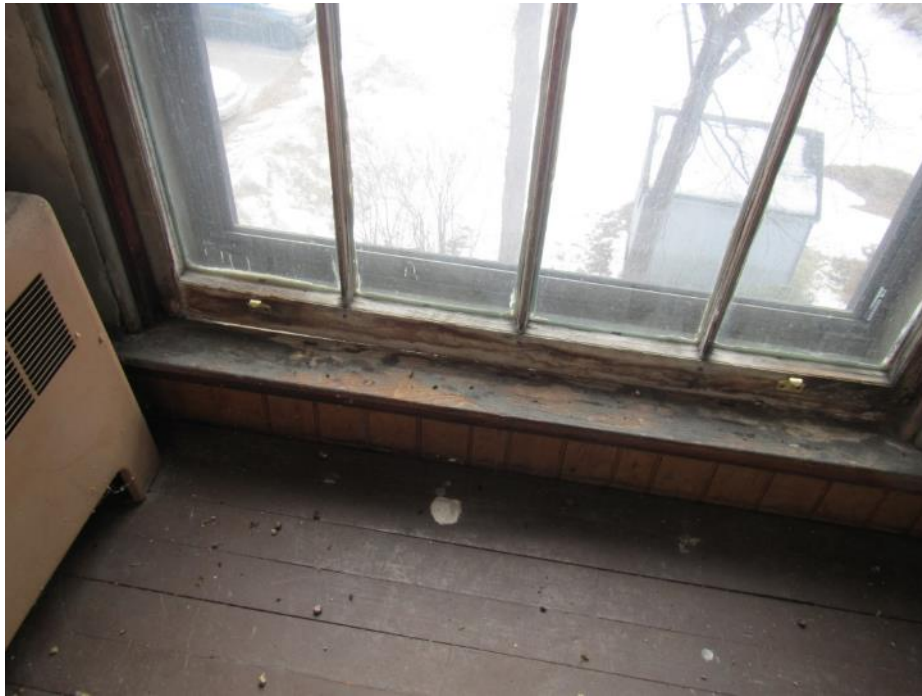
Picture 7

Other issues were identified that may contribute to IAQ issues. Dust and debris was found in the building, particularly on the attic level (Picture 7). This material indicates that wood and other materials are deteriorating, and it may be a source of irritating dusts. This debris may also contain waste from pests such as the reported squirrels, other rodents, or birds, all of which can be a source of allergens. Curtains remaining in the attic level are stained with what appears to be bird waste (Picture 17).

Damaged window

17. Regularly clean dust and debris from surfaces in the building. Flag areas with significant accumulations of dust/debris to check for potential pests, and for future repairs/replacement of wood and masonry.

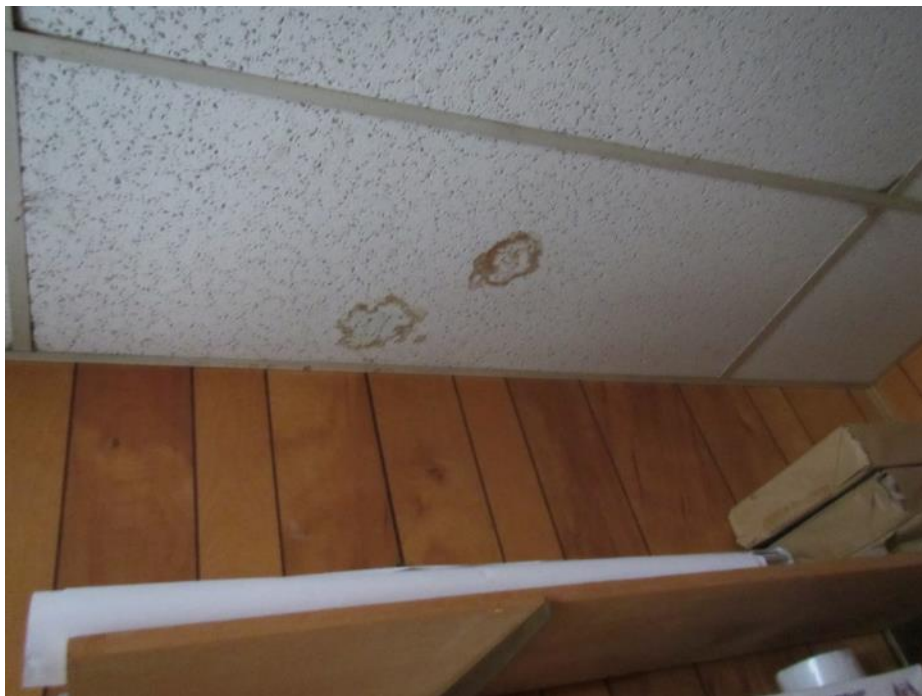
Picture 8

Water-damaged ceiling tiles are present in other areas (Pictures 8 and 9) which may be due to building envelope leaks (e.g. damaged/missing flashing or window sealant) or leaks from the plumbing system. The dark staining on the ceiling tiles shown in Picture 9 may be mold colonization. Water-damaged ceiling tiles should be replaced after a leak is repaired or when colonized with mold.

Water-damaged ceiling tiles

13. Consider moving water coolers to areas without carpeting.
14. Ensure refrigerators are kept clean to prevent odors.
15. Ensure water-damaged materials are cleaned, replaced, and/or repaired in a manner consistent with the U.S. Environmental Protection Agency's guidelines (US EPA, 2008).

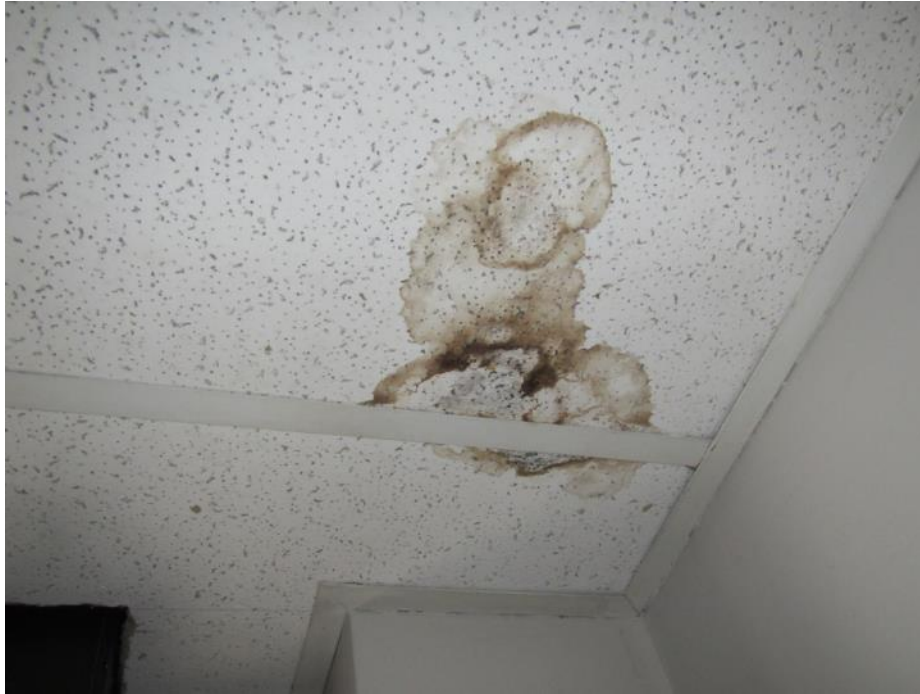
Picture 9

Water-damaged ceiling tiles, dark stains may indicate mold growth

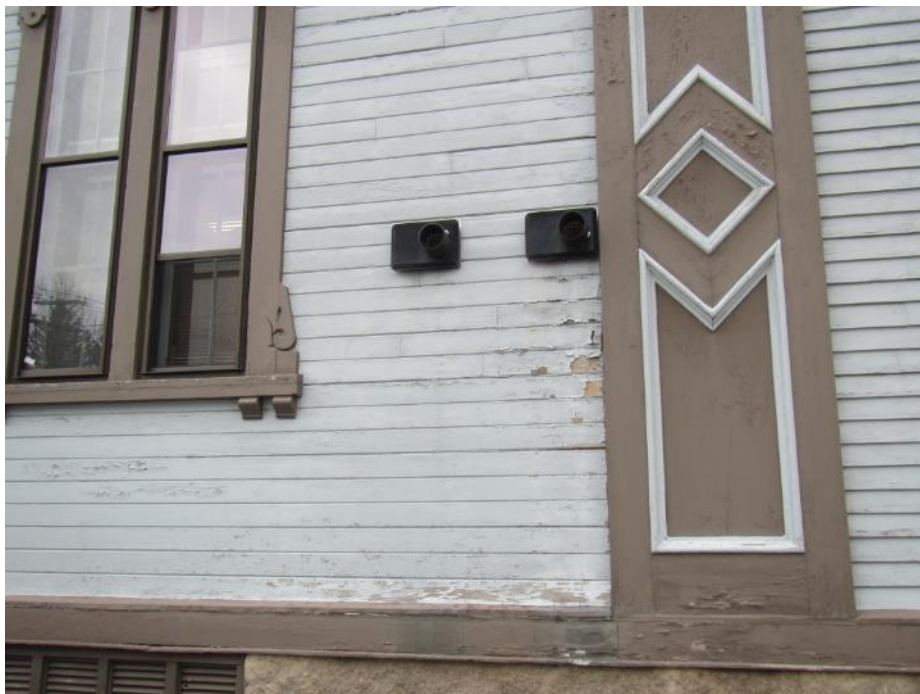
Picture 10

Clapboards on the exterior of the building are deteriorated in some areas (Picture 10). Bricks in the area of the lower level vault also show signs of deterioration and efflorescence (Picture 11).

Deteriorated siding

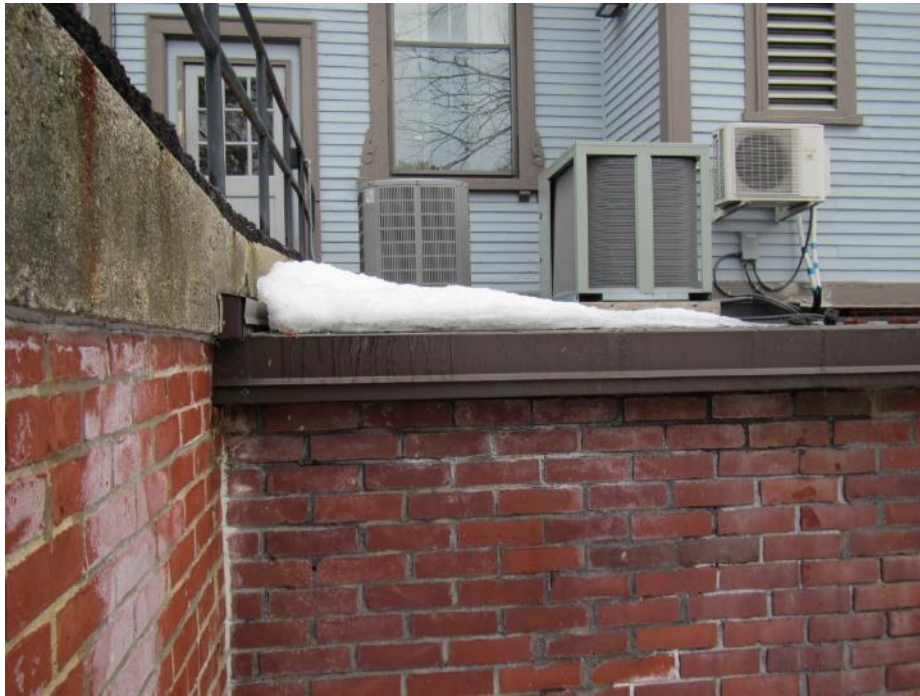
Picture 11

Damaged brick and efflorescence in the area of the lower vault

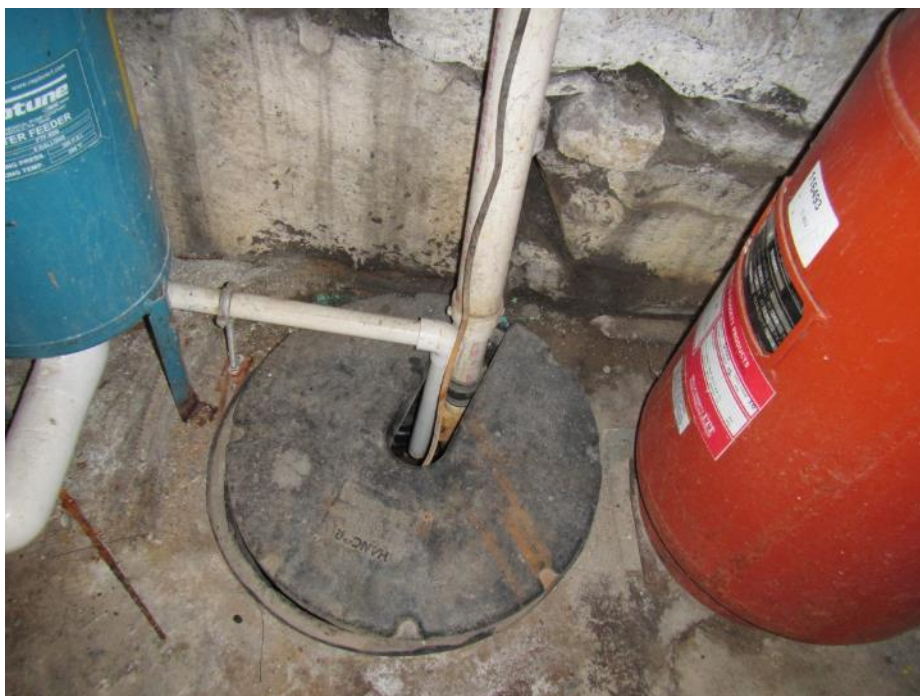
Picture 12

The furnace room is located on the same hallway as several offices, including the Board of Health office. Odors from this room have been reported. The room has a rough rock wall (Picture 12) and is below grade which contributes to moisture issues. There is also a sump with pump in this room (Picture 12); an air-tight cover should be used to prevent odors from the

Rock wall and sump with gap in lid in the furnace room

sump. Weather-stripping can be used to further seal the door between this room and the hallway so long as adequate combustion make-up air is available.

9. If sufficient makeup air is available for the furnace room with the hallway door tightly sealed, use weather-stripping to render that door airtight.

10. Equip the sump in the furnace room with a tight-fitting cover.
11. Seal the floor drain in the vault.
12. Maintain plants and do not overwater. Ensure they are placed on non-porous drip pans that are cleaned periodically.

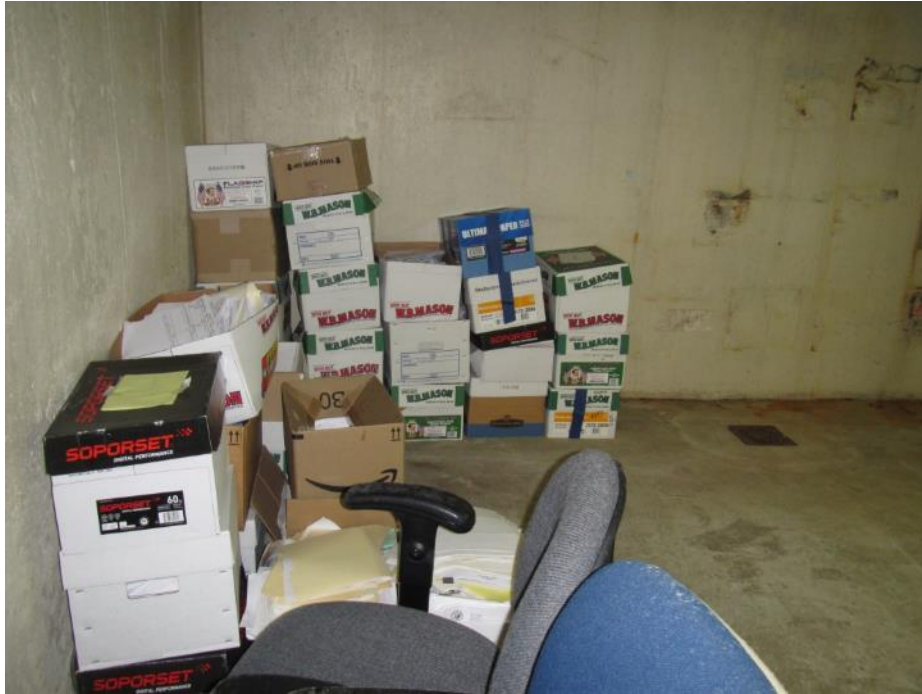
Picture 13

The vault on the lower level has a floor drain (Picture 13). This drain should be sealed to prevent sewer gases or backups into the space. Because of this, and because of the potential for condensation on the floor, items stored here should be on raised shelving or pallets.

Floor drain and stored boxes in the lower level vault

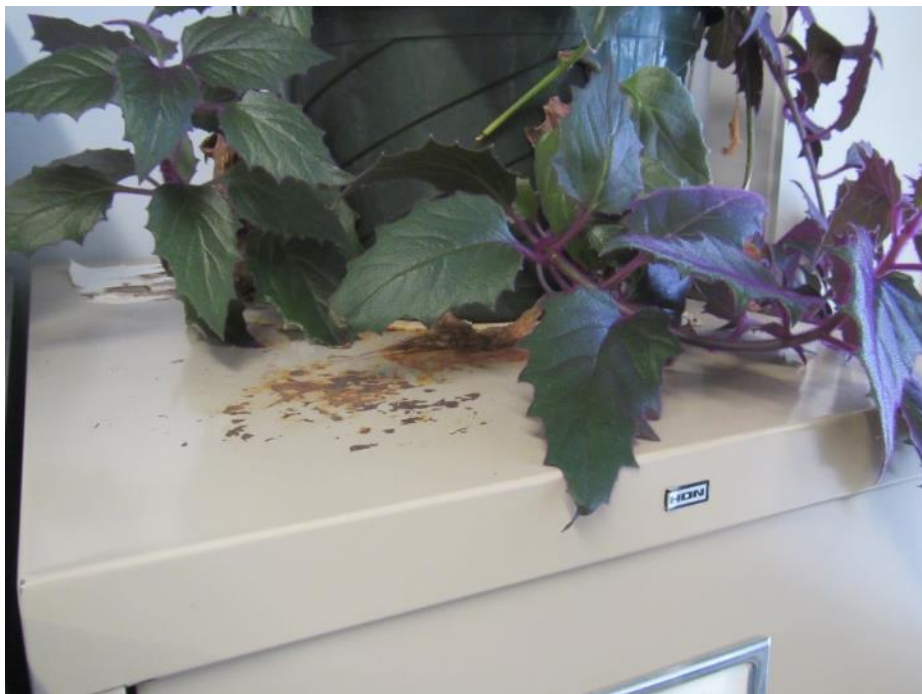
Picture 14

Plants were noted in several areas (Picture 14). Plants should be well maintained, placed only on non-porous drip pans, and kept away from ventilation equipment to prevent the distribution of pollen, mold and odors. Water damage to surfaces from plants was noted (Picture 14). Water dispensers were found on carpet (Picture 15). These appliances can spill or leak and moisten carpeting, so should be placed in non-carpeted areas whenever possible. The refrigerator on the upper level had evidence of a spill (Picture 16). Refrigerators should be kept clean to prevent odors and microbial growth.

Plant and water-damaged metal cabinet

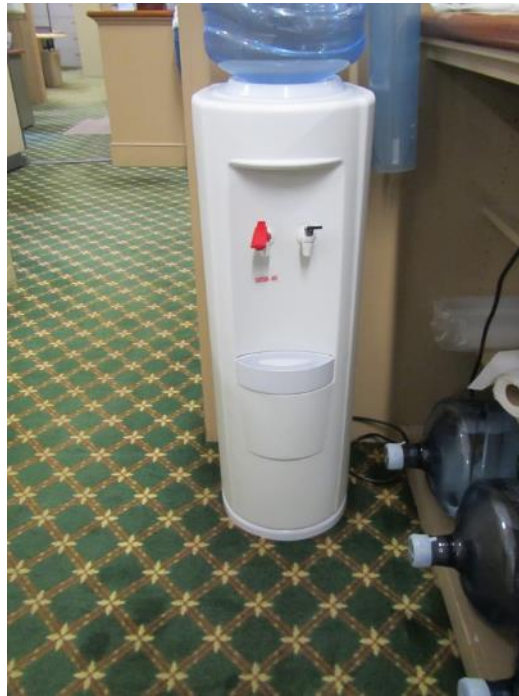
Picture 15

Water cooler on carpet

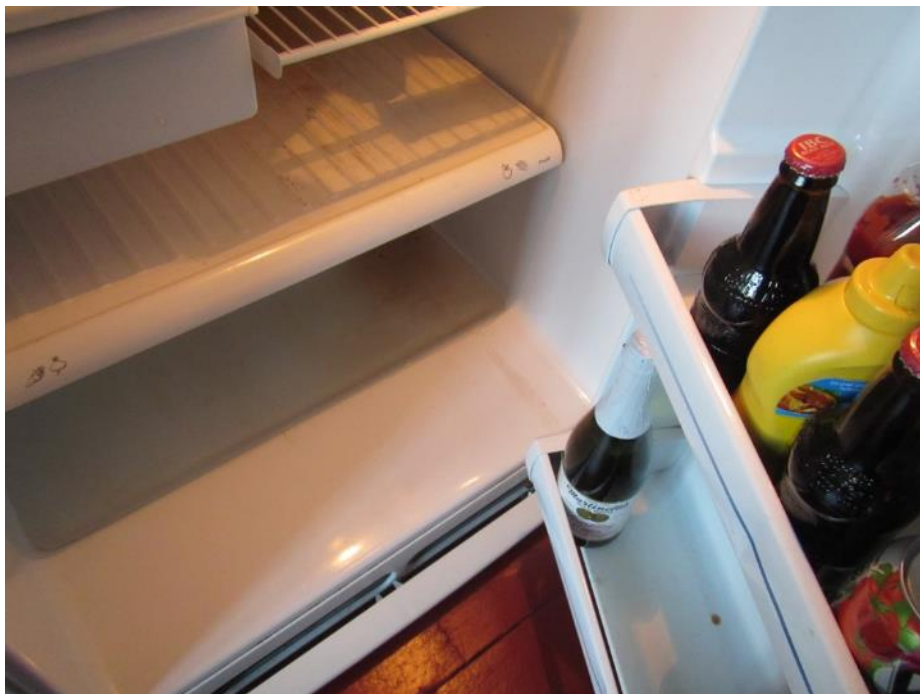
Picture 16

Evidence of spill in fridge

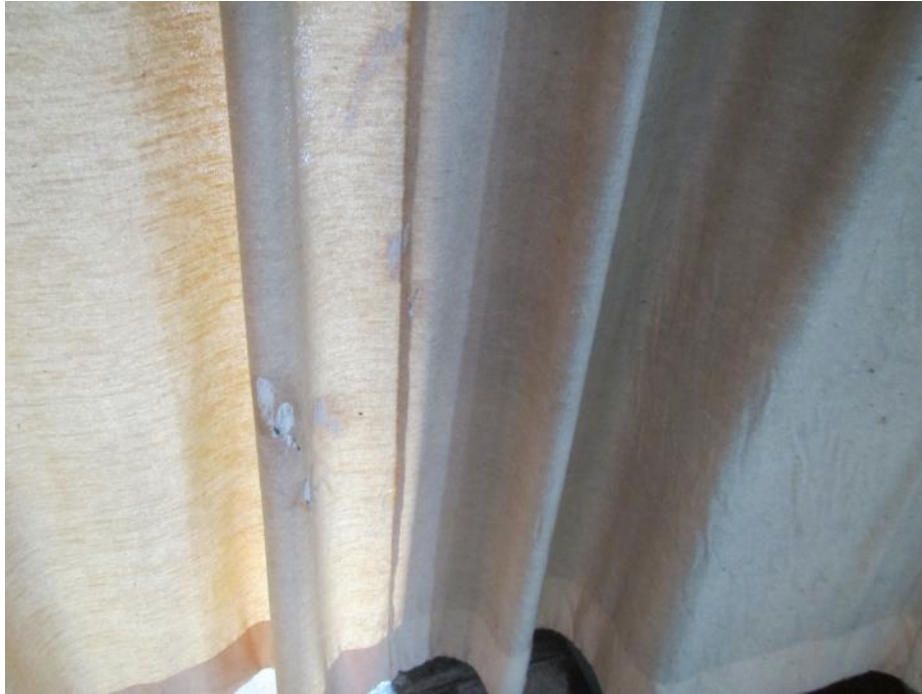
Picture 17

Curtain stained with bird waste

18. Clean the curtains in the upper level (Picture 17), or remove them.
19. For buildings in New England, periods of low relative humidity during the winter are often unavoidable. Therefore, scrupulous cleaning practices should be adopted to minimize common indoor air contaminants whose irritant effects can be enhanced when the relative humidity is low. To control for dusts, a high efficiency particulate arrestance (HEPA) filter equipped vacuum cleaner in conjunction with wet wiping of all surfaces is recommended. Avoid the use of feather dusters. Drinking water during the day can help ease some symptoms associated with a dry environment (throat and sinus irritations).

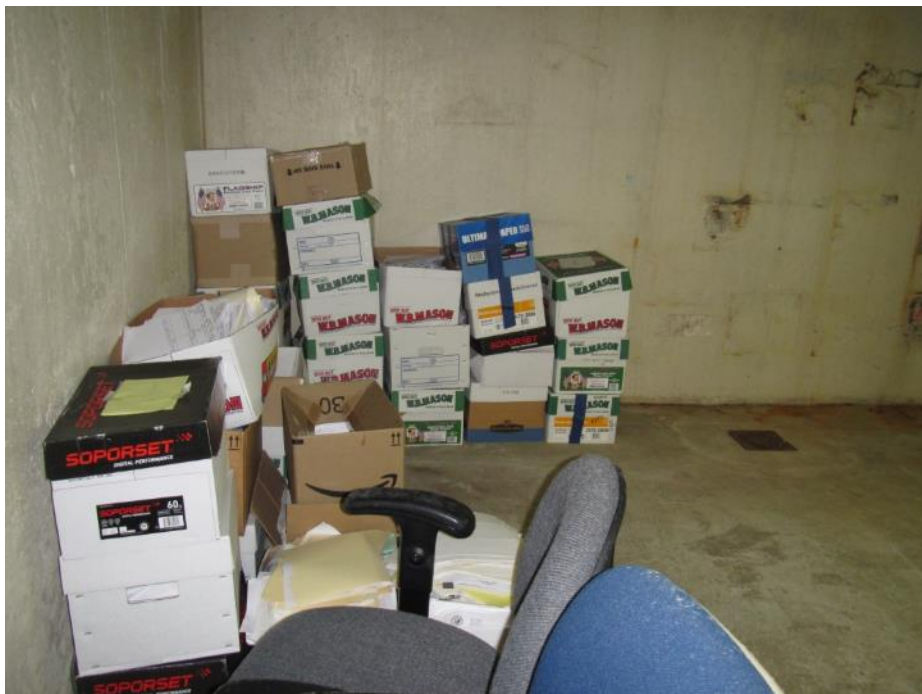
Picture 18

Stored materials are present in all areas of the building, including large amounts of paper (Pictures 18 and 19). This material can become damaged due to exposure to temperature extremes and moisture in unconditioned spaces, and may also become harborage/food for pests. Porous materials such as paper should be stored in an organized manner and should be kept off the floor, particularly on the lower level where condensation may occur on the floor during

Boxes on the floor of the lower level vault – note floor drain

16. Store items in the building neatly and away from any areas with known leaks or water issues, including floors. Use totes, shelves, or cabinets to store items neatly and prevent moistening, dust buildup, and pest harborage.

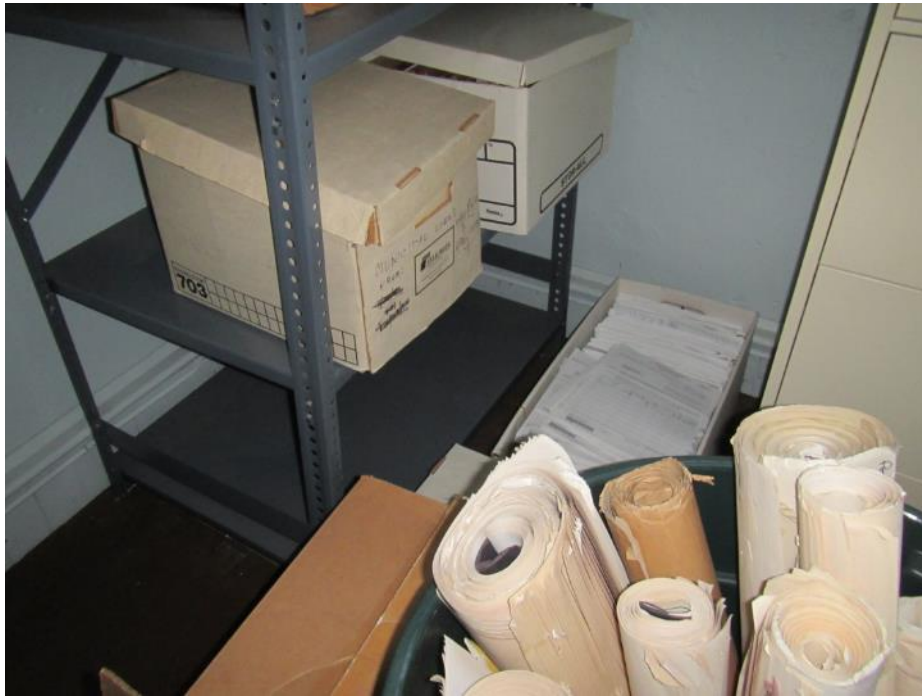
Picture 19

Storage of old files and plans in the upper level
